## Case Report

# Inappropriate Shock Due to Subcutaneous Lead Body Fracture: Extraction and Reimplantation

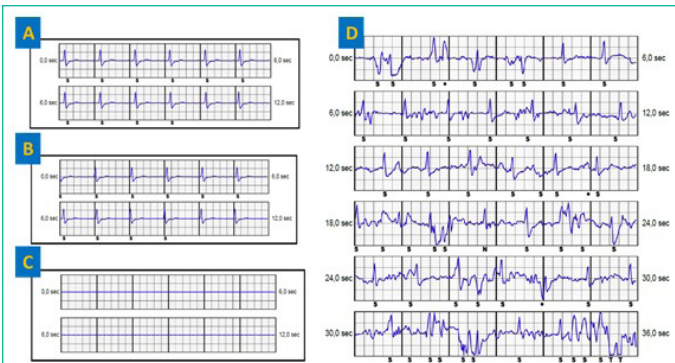
The 3 events showed mechanical artifacts. S-ECG control reveals identical primary and secondary vectors and a flat alternate vector (Figure 1). Chest X-ray with front and left profile confirmed the lead rupture at the left xypho-sternal angle as described in the literature. The patient was asymptomatic and did not report any chest trauma.

**Figure 1:** (A) Primary vector. (B) Secondary vector, similar to the primary vector. (C) Flat alternate vector (D) event classified as VT showing mechanical artifacts.

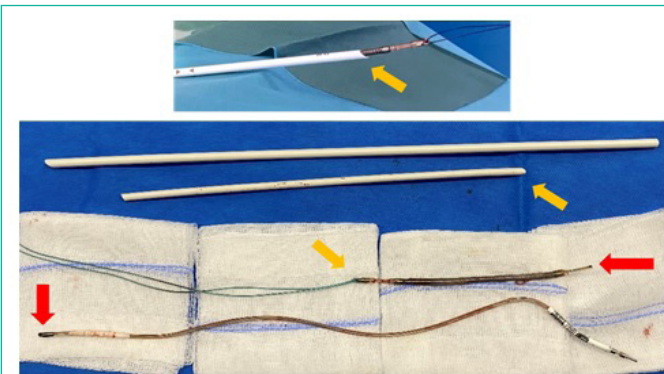
With a xyphoid incision, we were able to visualize a clear fracture immediately after the distal part of the proximal electrode. The proximal part of the lead was removed by simple traction without difficulties.

**Figure 2:** Top: extracted lead with the dilator sheath through distal incision.

**Bottom:** Lead extracted in 2 pieces thanks to the dilator sheath. Red arrows indicate the fracture point. In orange, the direction of extraction.

To avoid partial extraction of the remaining part, in particular unwinding of the coil [5], an additional incision in distality of the lead was made. A Cook dilator sheath (ref. G19860, internal diameter 11,5Fr, length 38cm) was used; this was adjusted to the remaining length of the lead. A solid thread was inserted into the hole at the end of the lead and then mounted in the extraction sheath, which in turn was inserted through the distal incision. The lead was freed from all adhesions by making push-pull between the lead and the sheath, supplemented by clockwise and counter clockwise rotations of the sheath.

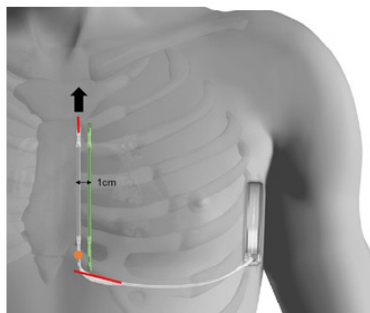
**Figure 3:** ●: Fracture point of the lead, distally to the proximal electrode

**In red:** The 2 incisions made

**Arrow:** Direction of extraction, through the supplementary distal incision

**In green:** New tunneling 1cm away from the initial lead

The detection parameters of the previous electrode were deemed appropriate. Therefore, the new device was also implanted left parasternal side. The additional distal incision made to extract the lead was closed to proceed to a classic 2-incisions implant technique. A new tunneling was carried out in parallel to the sternum, 1cm left away from the initial lead to avoid

any floating of the lead (Figure 3). The system was tested with success (65J, 74ohms, time to treatment 17s). The control X-ray shows good positioning of the device.
