## Case Report

# An Uncommon Management of Fractured Narrow Implant: Clinical Case Report

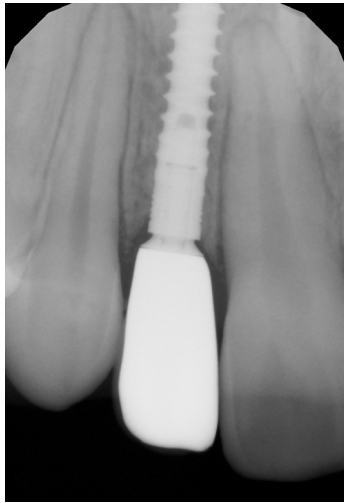
Figure 3: X- ray of implant reg. 12.

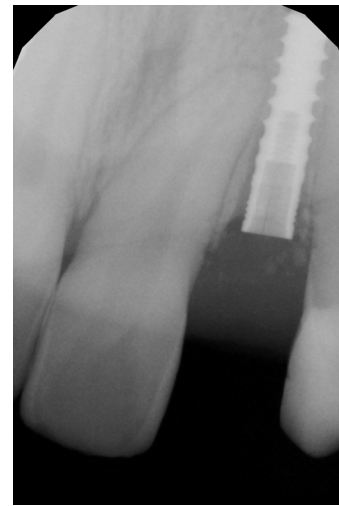
In October 2019, a check of the implants was carried out. Subjectively, she reported feeling a wiggle crown reg 22. On clinical examination, the tissues around the implant were free of inflammation, and both crowns were firmly fixed. Intraoral radiograph showed evidence of coronal disintegration of the coronal part at implant 22 (Figure 5). The patient was scheduled for a follow-up appointment in six months. In March 2020, the patient presents with a loose crown from the reg 22 implant. According to the i.o. X-ray, there is a longitudinal fracture in the coronal part of the implant (Figure 6). Due to the position of

Figure 6: Implant fracture.

the implant in this situation, the proximity of the surrounding teeth and the alveolar structure, we abandoned explanation and agreed on a solution using a reinforcement ring placed in the area of the fracture. Subsequently, in agreement with Lasak co., titanium rings were fabricated with different diameters (3.1 mm, 3.2 mm, 3.3 mm and 3.4 mm), 2,5 mm height and 0.2 mm width from grade 4 titanium (Figure 7).

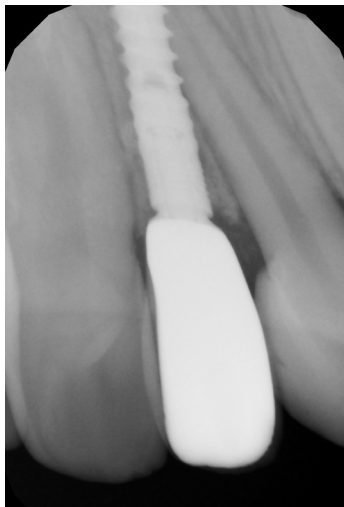
Figure 4: X-ray of implant reg 22.

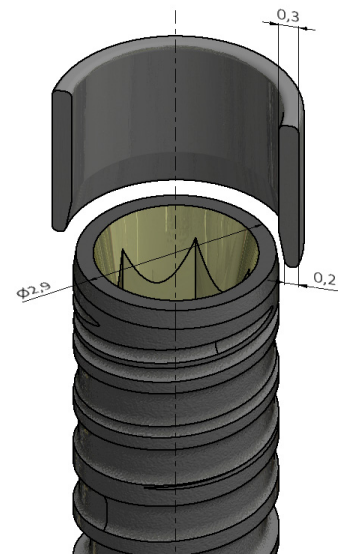
Figure 7: Scheme of titanium reinforcement ring.

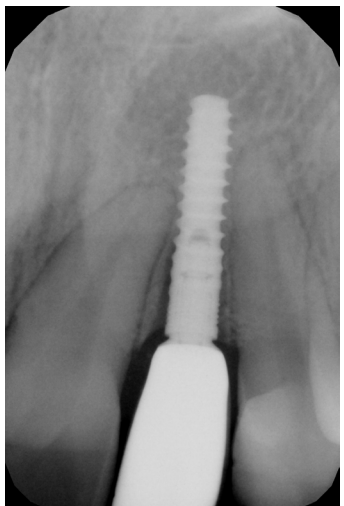
Figure 5.: Bone resorption around neck of the implant reg. 22.

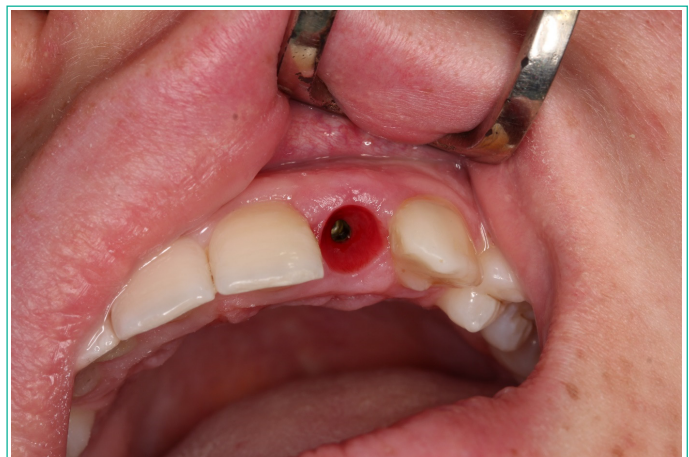
Figure 8: The situation after losing the crown.

In May 2020, a surgical procedure was performed to place a ring in the area of the implant fracture. A ring with a diameter of 3.3 mm was selected for passive adaptation. At the same time, the crown was fixed with tightening of the fixation screw to 15

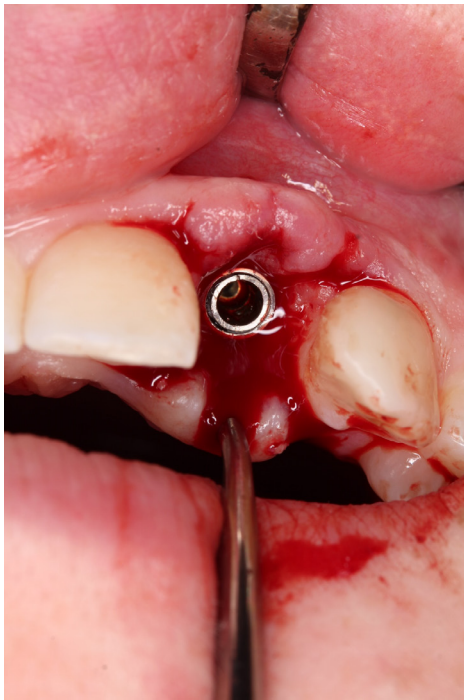
Figure 9: The ring adaptation.

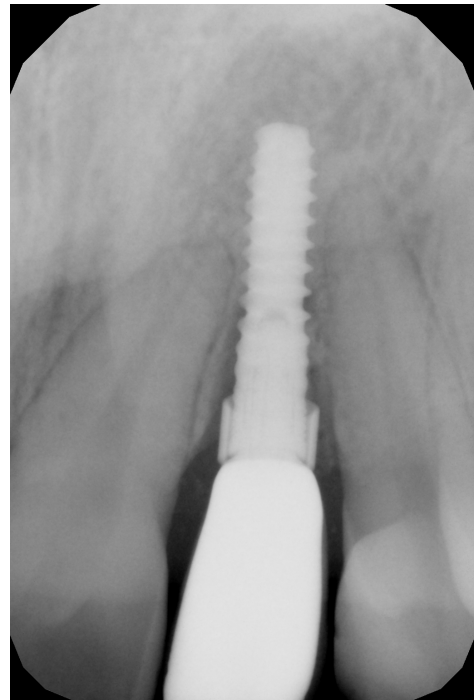
N/cm (Figure 8,9 & 10). Subsequently, follow-ups were performed every 2 months until June 2020. The prosthetic work remained firm, and the patient was free of problems. Further check-ups took place every six months. At the last follow-up in June 2023, the patient was subjectively uncomfortable, the work was aesthetically and functionally satisfactory, and the intraoral radiograph showed no progression of alveolar loss in the neck-implant area (Figure 11,12 & 13).

Figure 12: X- ray three years later.

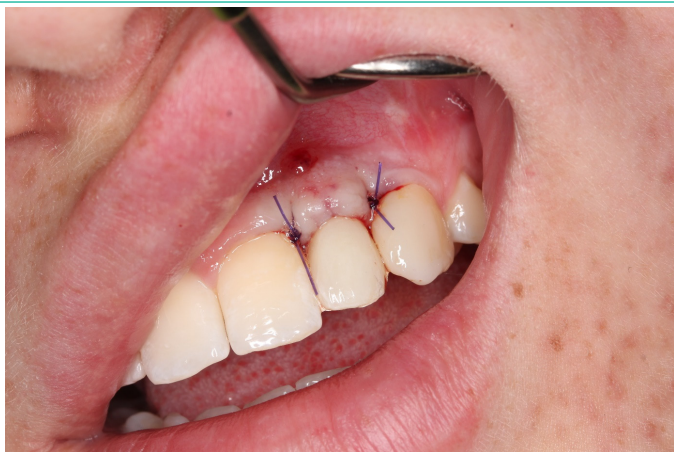
Figure 10: The situation after crown fixation.

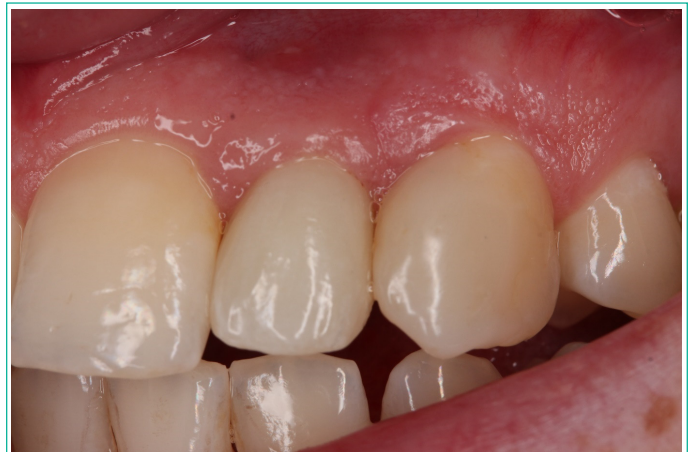
Figure 13: Clinical view three years later.

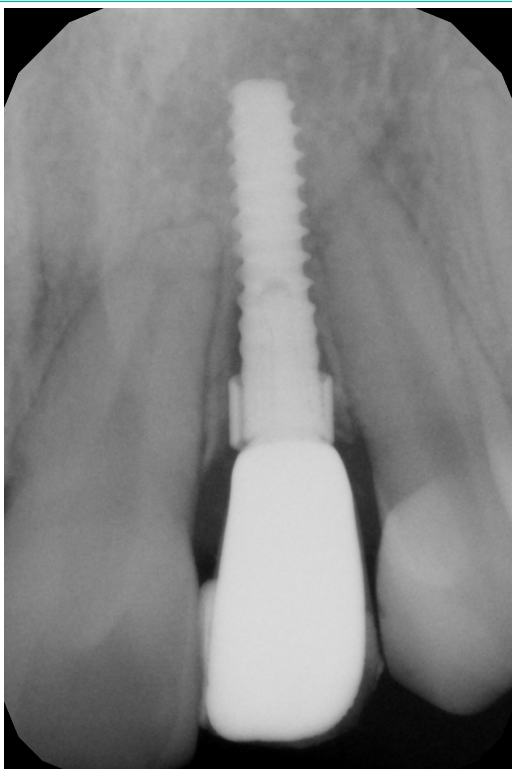
Figure 11: X-ray after surgery.
