Case Presentation

Direct Restoration of Posterior Teeth Using Stamp Technique and Bulk-Fill Composite Resin

Mabrouk R*, Oueslati A and Frih N

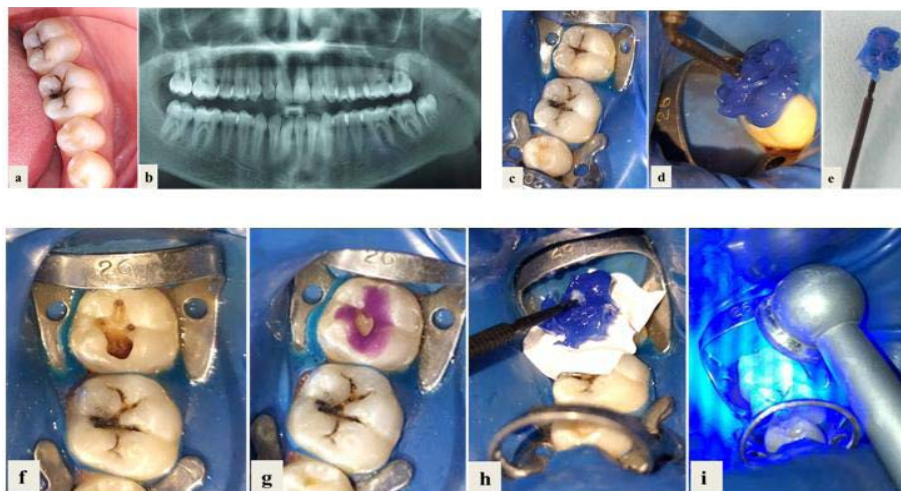
on site 1 within the occlusal table of mandibular first left molar #36. However, the second mandibular left molar #37 presented a carious lesion in the occlusal pits and grooves showing minimal occlusal structure changes. Test sensibility showed a reversible mild sensibility of cold for both teeth. The panoramic radiograph revealed a carious lesion extending to the medium inner of the dentin in the #37. As the occlusal site was seemingly intact surface overlaying an extensive lesion, the carious lesion on tooth #37 was referred to a "hidden caries" (Figure 1 a&b).

Figure 1: The stamp technique for site 1 on tooth #37. (a): Intraoral preoperative view; (b): Panoramic view showing the extension of the hidden caries on the second left mandibular molar tooth #37; (c): Rubber dam isolation; (d): Flowable composite resin with a microbrush; (e): The composite stamp; (f): Cavity preparation; (g): Etching; (h): The cavity was filled with bulk fill composite to level 1 mm below the occlusal surface followed by the placement of Teflon tape and the occlusal stamp; (i): Light curing after removing the stamp and Teflon tape.

The diagnosis of reversible pulp inflammation was retained for both teeth #36 and #37. Taking into account that the occlusal surface of the involved teeth had no change in their morphologies, we opted for the occlusal stamp technique for resin composite restoration of both teeth. First of all, teeth were cleaned with a silk brush and a prophylactic paste. Then, shade selection was performed using a VITA shade guide. After local anesthesia, the dam rubber dam was placed keeping the operating field dry and free of contaminants. A fine coat of Vaseline, a separating agent, was applied on the occlusal surface of the teeth to detach easily the impression material. The composite resin Ultradent™ LC Block-Out Resin material was applied to the occlusal surface, an applicator was immersed into it without touching the dental surface and the micro-brush was maintained over it with a gentle digital pressure than light-cured to fabricate the occlusal stamp. It was light cured and thus occlusal stamp was fabricated. After its complete curing, the stamp was removed and the corresponding edge on the buccal surface of the tooth was marked for orientation at the time of the stamp repositioning (Figure 1c,d&e).

Carious tissues were removed throughout the occlusal access of the #37 and a site 1 cavity adhesive preparation was prepared. After the complete removal of the carious lesion, the cavity was rinsed with chlorhexidine solution 0.2% and the dentin-pulp complex was lined with calcium hydroxide phosphate cement liner (Biner LC, Meta Biomed').

Selective Enamel etching was done using 37% phosphoric acid (Meta Etchant, Meta Biomed') for 30 seconds followed by dentin for 15s. The cavity was abundantly rinsed, then dried carefully with chip blower to obtain white frosted appearance in enamel. However, the surface of the dentin was kept slightly moistened the must be left moist "wet bonding", in order to avoid collagen collapse by absorbing excessive water using a cotton pellet. The cavity margins were then coated with a bonding agent (Ambar universal bonding FGM') and light-cured for 20 seconds with an LED source. The cavity was restored using a bulk nano-hybrid composite resin (Opus Bulk Fill APS, FGM') up to 1 mm lower of the occlusal surface then light cured for 20s. The final increment layer of composite resin was added and before light curing, a piece of Teflon film was applied on the occlusal surface. The

occlusal stamp, previously done, was firmly placed over the Teflon tape to achieve the morphological configuration corresponding to the initial situation of the occlusal surface. Next, the tape was removed and the occlusal excess of composite resin was eliminated then light cured for 40s using LED source (Figure 1 f,g,h&i).

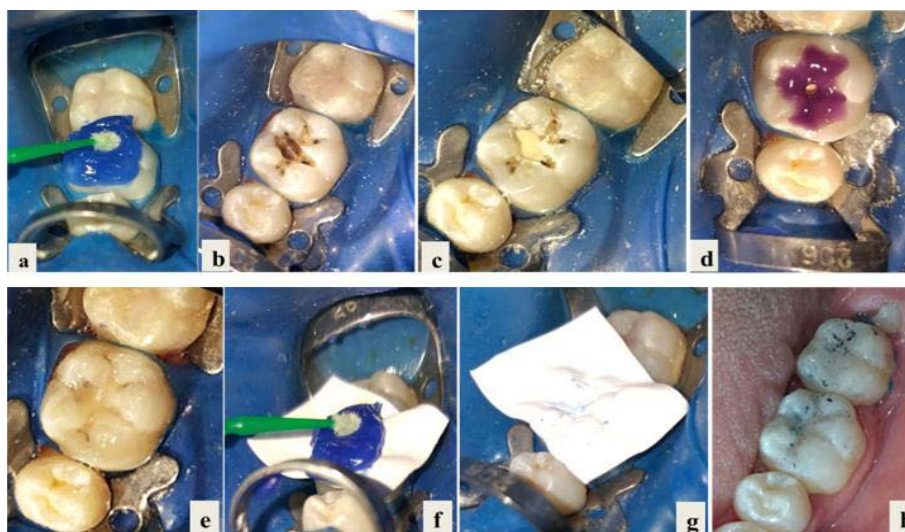
Figure 2: The stamp technique for site 1 cavity of the tooth #36. (a): The stamp; (b): caries removal; (c): calcium hydroxide lining; (d): phosphoric acid etching; (e): the cavity was filled with bulk fill composite resin; (f): the placement of Teflon tape and the occlusal stamp; (g): view directly after removing the stamp; (h): postoperative intra oral view.

Assuming the second left mandibular molar #37, the first left mandibular molar #36 was launched. The tooth was restored in the same manner (Figure 2 a,b,c,d,e,f&g).

The surfaces were polished using fine-grained abrasive flexible discs (SofLex Discs, 3M ESPE) and silicone polishing points. Finally, the rubber dam was removed and occlusion relations were checked and it was found that there was no need for adjustment. The

immediate result duplicates the original surface anatomy (Figure 2h).
